Logan Road and O'Keefe Street

Existing Road Stage Road Safety Audit

Final

June 2018

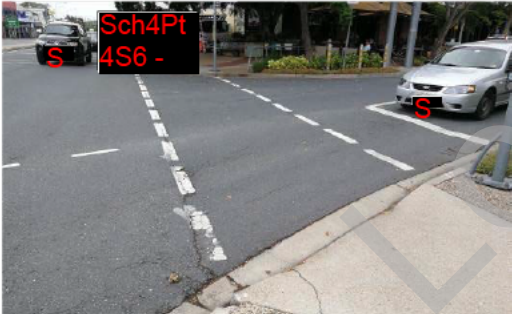
Item	Location	Issue/Risk Description	Risk	Possible Solution	Client Response
1.	WPT 1

<p>Signs of pavement failure are present on Logan Road, immediately prior to the Old Cleveland Road intersection. If left untreated, this condition is expected to worsen.</p> <p>Potholes, cracking and level differences in the pavement can introduce control issues for motorcyclists and bicycle riders and increase the risk for falling incidents.</p> <p>It is also a pedestrian trip hazard due to the uneven walking surface for pedestrians crossing Logan Road. There is risk of injury to motorcyclists, cyclists and pedestrians.</p>	LOW (2)	Consider undertaking pavement works.

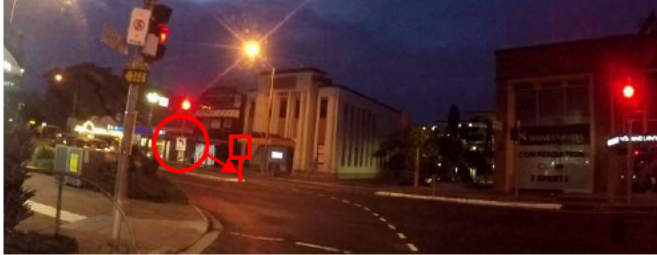
Item	Location	Issue/Risk Description	Risk	Possible Solution	Client Response
2.	WPT 2

<p>The entry plaza to the Busway station may give the appearance of a roadway to northbound drivers on Logan Road approaching Old Cleveland Road. A left turn pavement arrow is provided but partially removed by service trenching. A Left Turn Only sign is installed in Old Cleveland Road but is positioned to the left of the intersection (i.e. not directly in the field of view of drivers looking towards the plaza). A driver may not realise that they cannot continue through to the plaza until they have proceeded part way across the intersection. Increased risk of angle collisions.</p>	LOW (2)	Consider relocating the left only sign more centrally in the field of view of approaching drivers. Consider repainting the left turn pavement arrow.

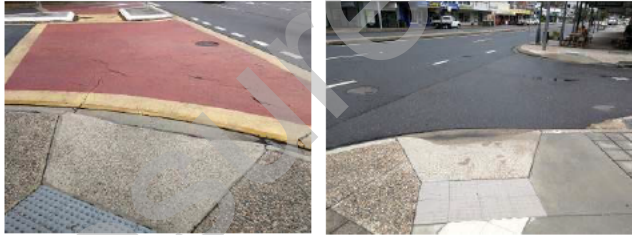
3.	WPT 3, WPT 4, WPT 42, WPT 43, WPT 44

<p>There are numerous kerb ramps not aligned with the receiving kerb ramps throughout the corridor. Visually impaired pedestrians may rely on the alignment to identify where the receiving kerb ramp is located, and could be directed onto the carriageway. Increased risk of pedestrian and vehicle conflict.</p>	LOW (2)	Consider realigning the kerb ramps.

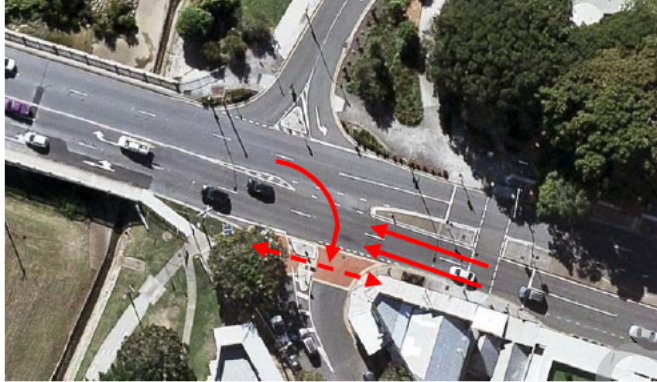
Item	Location	Issue/Risk Description	Risk	Possible Solution	Client Response
4.	WPT 5

<p>Vehicles turning right from Logan Road into Cleveland Street experience moderate levels of delay in peak periods. The footpath on the southern side of Logan Road caters for significant use. No dedicated right turn lane is provided, and vehicles propped to turn right partially block the right-hand through lane.</p> <p>Due to a combination of delays and wanting to avoid blocking traffic, drivers are more likely to fail to yield to pedestrians or cyclists crossing Cleveland Street.</p> <p>Risk of vehicle collisions with vulnerable road users.</p>	MEDIUM (5)	<p>Consider installing dedicated right turn lane.</p> <p>Consider signalling the intersection.</p> <p>Consider banning the right turn into Cleveland Street (during peak periods).</p>

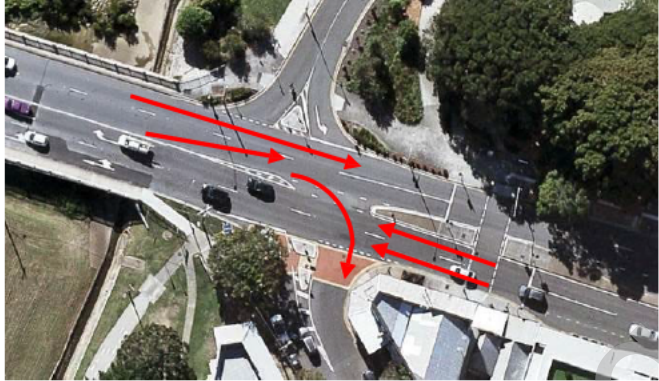
Item	Location	Issue/Risk Description	Risk	Possible Solution	Client Response
5.	WPT 6

<p>The widened 'median' allows right turning vehicles to partially move out of the through lane but not completely. Passing drivers may misjudge the available width for passing in the right-hand lane. Risk of side swipe and offset rear end collisions.</p>	MEDIUM (5)	<p>Consider providing a right turn lane. Consider banning the right turn. Consider reconfiguring arrangements to remove ambiguity. i.e. so that any propped vehicles are positioned wholly within the through lane.</p>

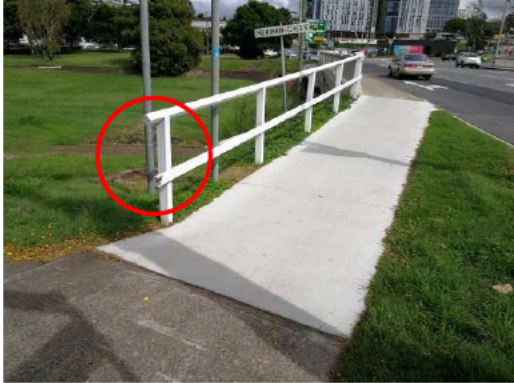
Item	Location	Issue/Risk Description	Risk	Possible Solution	Client Response
6.	WPT 7

<p>The timber fence on the southern side of Logan Road has horizontal rails that can be a spearing hazard if struck by passing cyclists. It is also a snag hazard as the ends of the rails project beyond the end post. Risk of higher injury if struck by cyclists.</p>	MEDIUM (5)	Consider replacing with conventional pedestrian fencing.

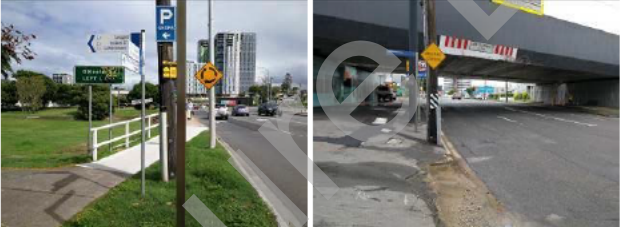
7.	WPT 9, WPT 18, WPT 29, WPT 33, WPT 34, WPT 37, WPT 40

<p>Non-frangible timber poles are located within the clear zone (including on the departure sides of the roundabout). Risk of higher severity injury if struck by errant vehicles.</p>	HIGH (8)	<p>SHORT TERM: Consider installing a hazard marker to delineate the power poles (where not already present).</p> <p>LONG TERM: Any plans to upgrade this corridor should consider relocation or undergrounding of power poles.</p>

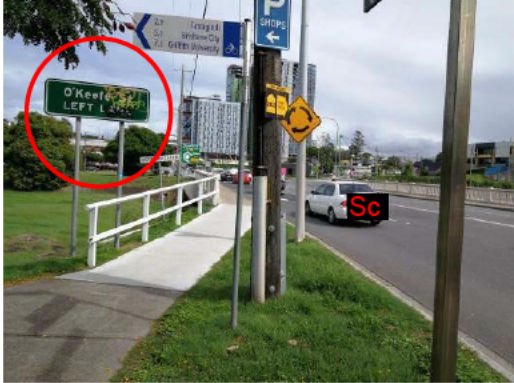
Item	Location	Issue/Risk Description	Risk	Possible Solution	Client Response
8.	WPT 8

<p>A directional sign is defaced and obscured by signs in the foreground. This may reduce awareness of directional movements for motorists unfamiliar with the area. Risk of late breaking/lane change manoeuvres leading to sideswipe and rear end collisions.</p>	LOW (2)	<p>Consider replacing the sign. Consider relocation of sign to a location where it is more visible to approaching traffic.</p>

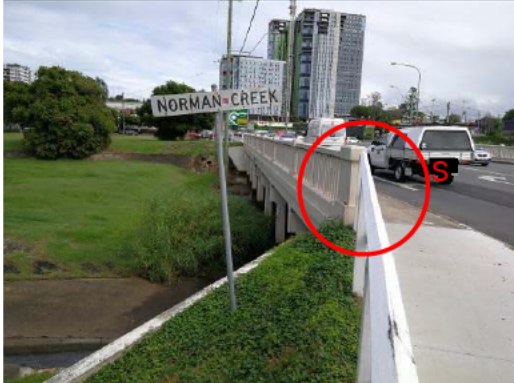
Item	Location	Issue/Risk Description	Risk	Possible Solution	Client Response
9.	WPT 10

<p>The barriers on the sides of the Norman Creek bridge do not have appropriate end treatments, and are a potential blunt impact hazard. Risk of higher severity injury to occupants of errant vehicles.</p>	HIGH (8)	Consider providing end treatments for all bridge barriers.	
10.	WPT 11

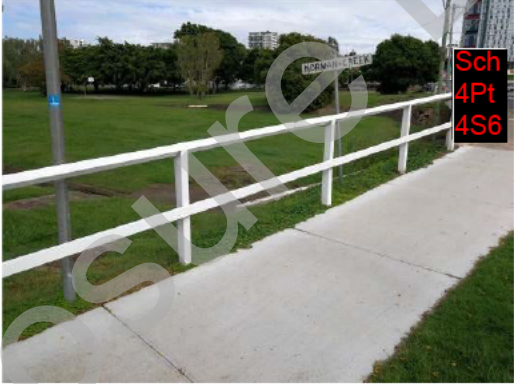
<p>The timber guardrail is insufficient to prevent a vehicle from entering Norman Creek upon impact. Risk of higher severity injury to occupants of errant vehicles.</p>	HIGH (7)	Consider providing a road safety barrier system that has an appropriate beginning length of need on both bridge approaches.

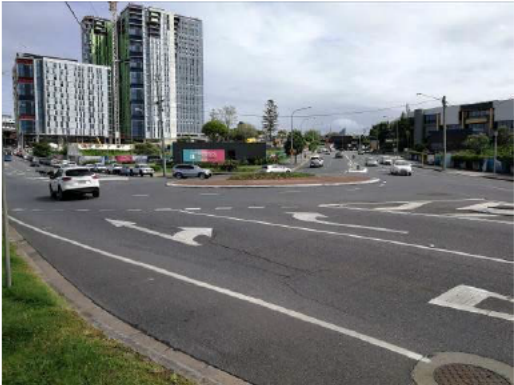
Item	Location	Issue/Risk Description	Risk	Possible Solution	Client Response
11.	WPT 12

<p data-bbox="613 667 1272 794">Delineation of the central island is limited to white paint on the kerb. Risk of vehicles mounting the island, particularly in poor visibility conditions on the O'Keefe Street approach.</p>	VERY LOW (1)	Consider installing hazard markers in the central island.

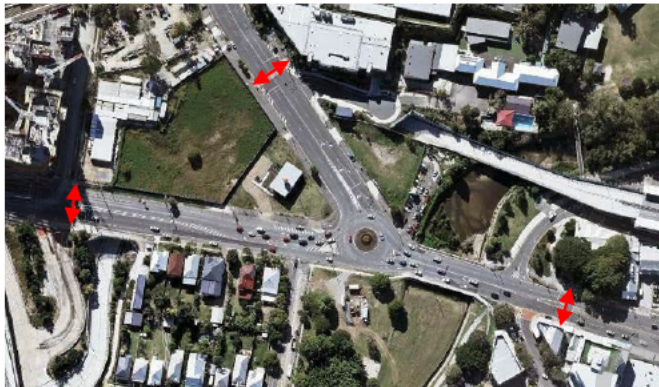
Item	Location	Issue/Risk Description	Risk	Possible Solution	Client Response
12.	WPT 13

<p>Existing footpaths naturally channelise pedestrians on Logan Road and O'Keefe Street towards the roundabout, but no crossing facilities exist at the roundabout itself (which is multi-lane and carries significant traffic volumes). Pedestrian demands in the area are high as a result of the surrounding land uses and public transport nodes. These demands will grow given planned high density residential development in the vicinity of the intersection.</p> <p>Pedestrians were observed crossing the road at non-signalised areas close to the roundabout.</p> <p>Increased risk of pedestrian and vehicle conflict.</p>	MEDIUM (4)	<p>Consider signalling the intersection.</p> <p>Consider installing pedestrian fencing behind the kerbs to channelise pedestrians towards existing crossings.</p> <p>Consider installing pedestrian wayfinding signage.</p>

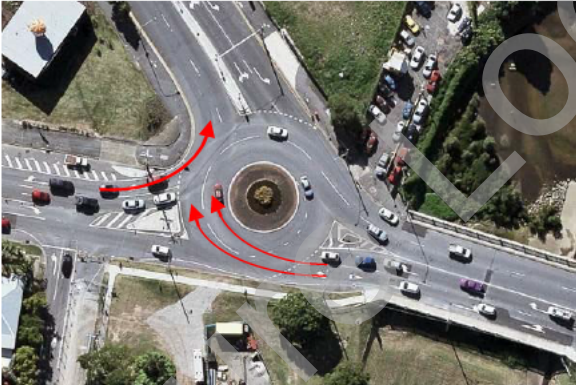
15.	WPT 16

<p>Right turns are permitted from both lanes on the westbound approach to the roundabout. Visibility of vehicles turning right from the left-hand lane may be obscured by vehicle in the inside circulating lane to drivers turning left at the eastbound approach (who do not need to give way to traffic on the inside lane). Risk of crashes involving left turning and right turning vehicles.</p>	MEDIUM (4)	<p>Consider signalling the roundabout. Consider restricting right turns on the westbound approach to the right-hand lane only.</p>

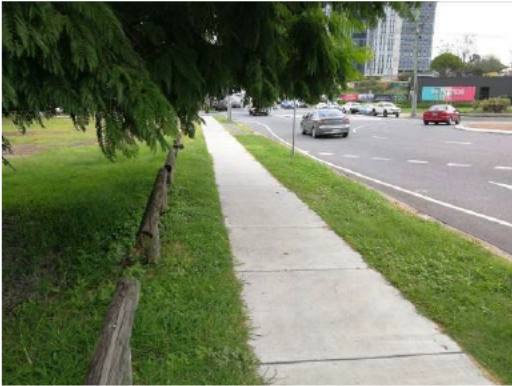
Item	Location	Issue/Risk Description	Risk	Possible Solution	Client Response
16.	WPT 17

<p>There is overgrown vegetation hanging over the footpath at a height of less than 1.5m. This is a clipping hazard for path users. Risk of injury to pedestrians cyclists.</p>	LOW (2)	Consider undertaking vegetation maintenance works.

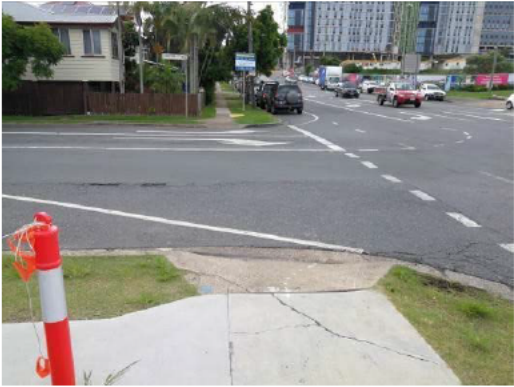
Item	Location	Issue/Risk Description	Risk	Possible Solution	Client Response
18.	WPT 20

<p>There are no Tactile Ground Surface Indicators to distinguish the holding point at the kerb ramps for path users crossing the Junction Street leg of the O'Keefe Street intersection. This intersection leg carries substantial traffic volumes in the peak periods. Increased risk of pedestrian and vehicle conflict.</p>	LOW (2)	Consider installing Tactile Ground Surface Indicators (TGSI) at the holding point.

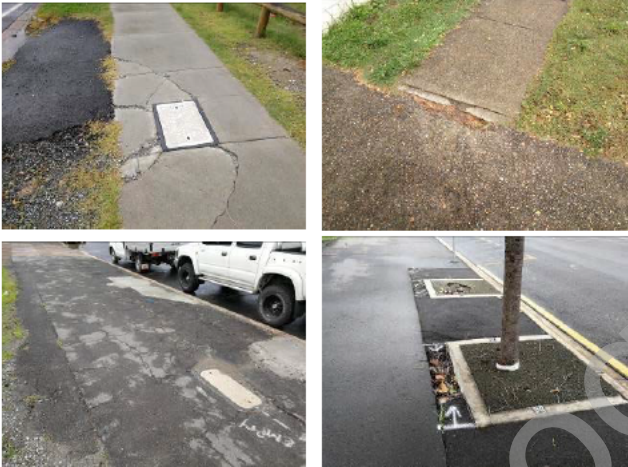
Item	Location	Issue/Risk Description	Risk	Possible Solution	Client Response
19.	WPT 22, WPT 25, WPT 26, WPT 27

<p>There are a number of instances of uneven level surfaces, gaps, drop-offs and cracks in the footpath throughout the corridor that are a hazard to pedestrians and cyclists and may result in slips, trips and falls. Risk of pedestrian and cyclist injury.</p>	LOW (3)	Consider undertaking footpath maintenance.

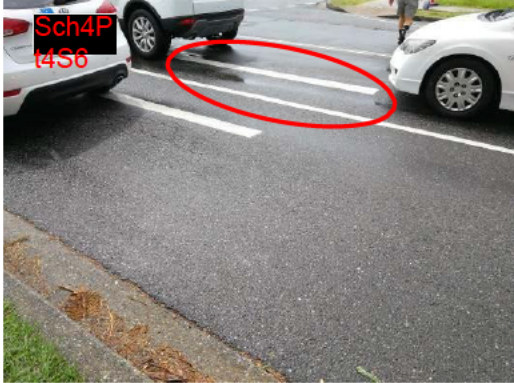
Item	Location	Issue/Risk Description	Risk	Possible Solution	Client Response
20.	WPT 23

<p>Signs of pavement failure are present on Junction Street, immediately prior to the O'Keefe Street intersection. If left untreated, this condition is expected to worsen.</p> <p>Potholes, cracking and level differences in the pavement can introduce control issues for motorcyclists and bicycle riders and increase the risk for falling incidents.</p> <p>It is also a pedestrian trip hazard due to the uneven walking surface for pedestrians crossing Junction Street.</p> <p>There is risk of injury to motorcyclists and cyclists.</p> <p>Risk of pedestrian injury.</p>	LOW (2)	Consider undertaking pavement works.

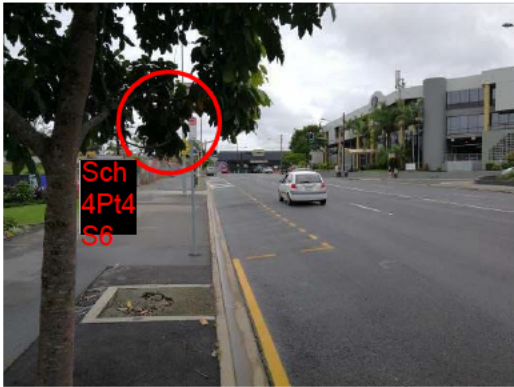
Item	Location	Issue/Risk Description	Risk	Possible Solution	Client Response
21.	WPT 28

<p>The left-hand side 60 km/h speed limit sign (for northbound motorists on Logan Road) is blocked by vegetation. This can potentially reduce motorist awareness of the change in speed restrictions. Increased variance in vehicle speeds may increase vehicle conflict.</p>	LOW (2)	Consider undertaking vegetation maintenance works.

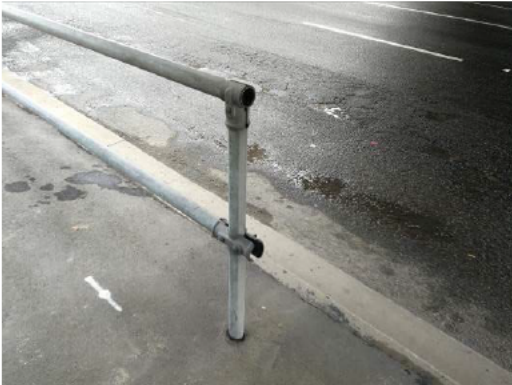
Item	Location	Issue/Risk Description	Risk	Possible Solution	Client Response
22.	WPT 31

<p>The tubular steel fencing in the western verge of Logan Road underneath the rail overbridge is a spear hazard in crashes involving errant vehicles. Risk of higher crash severity.</p>	MEDIUM (4)	Consider replacing the fencing with an alternative that does not have horizontal structural elements.

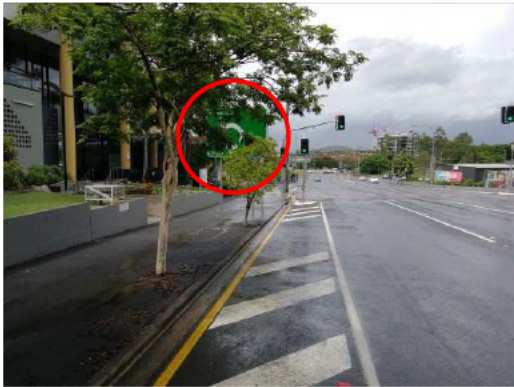
Item	Location	Issue/Risk Description	Risk	Possible Solution	Client Response
24.	WPT 36

<p>A directional sign on Logan Road southbound is obscured by vegetation in the foreground. This may reduce awareness of directional movements for motorists unfamiliar with the area. Risk of rear end and sideswipe crashes due to late braking or lane change manoeuvres.</p>	LOW (2)	Consider undertaking vegetation maintenance works.

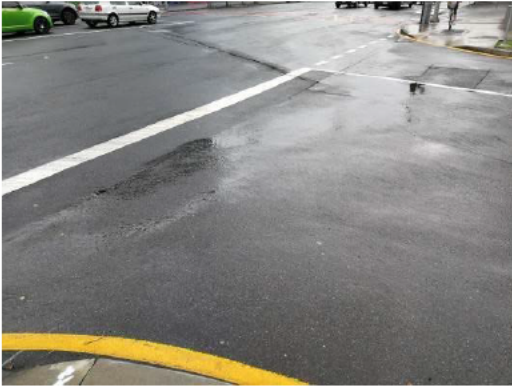
Item	Location	Issue/Risk Description	Risk	Possible Solution	Client Response
25.	WPT 38

<p>There is a 14.5m crossing distance between the northern and southern sides of Cowley Street at the Logan Road intersection. Pedestrians crossing at this this location are exposed to turning traffic for a long period, particularly during busy school peak periods. Increased risk of pedestrian and vehicle conflict.</p>	MEDIUM (4)	Consider installing a median refuge so that pedestrians can stage crossing manoeuvres.

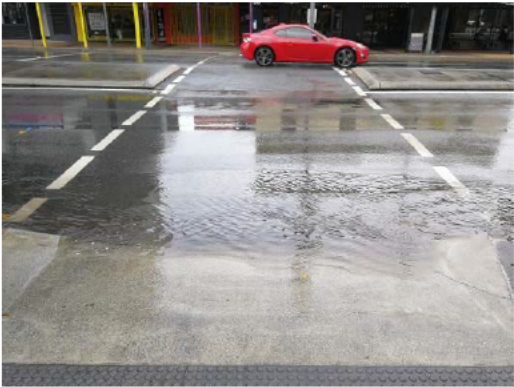
Item	Location	Issue/Risk Description	Risk	Possible Solution	Client Response
26.	WPT 41

<p>Significant ponding began to form at the northern side of the mid-block signalised crossing outside the Stones Corner Library during a rain event. It was observed that pedestrians navigated around the ponding outside of the pedestrian crossing to avoid the slip hazard, increasing the likelihood of conflict with vehicles. Increased risk of pedestrian and vehicle conflict.</p>	MEDIUM (4)	Consider undertaking works to improve drainage at this location.
